# Qualification of PV Materials

William Gambogi, DuPont Photovoltaic Solutions

# Module Failures due to UV Exposure: Polyester Yellowing and/or Cracking on Junction Box Side

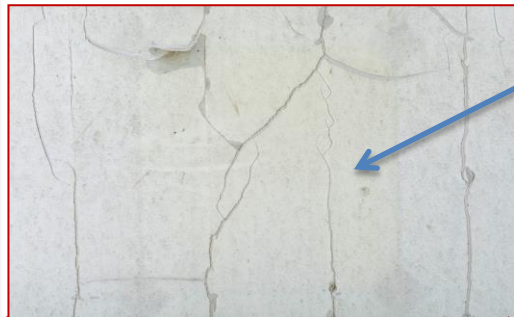
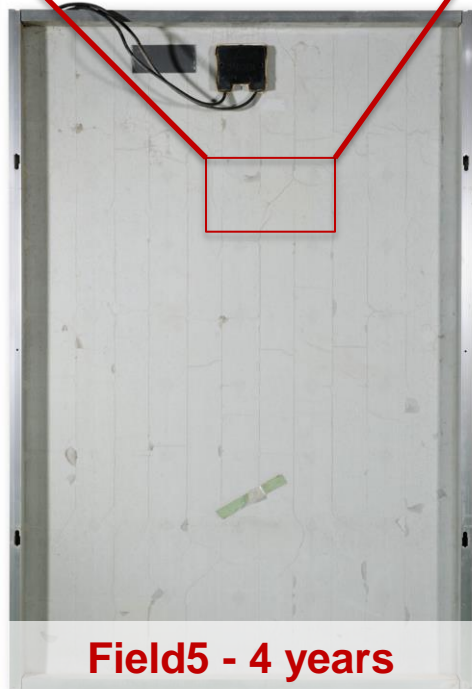
**Field5 - 4 years**

Cracking &  
Yellowing

Yellowing

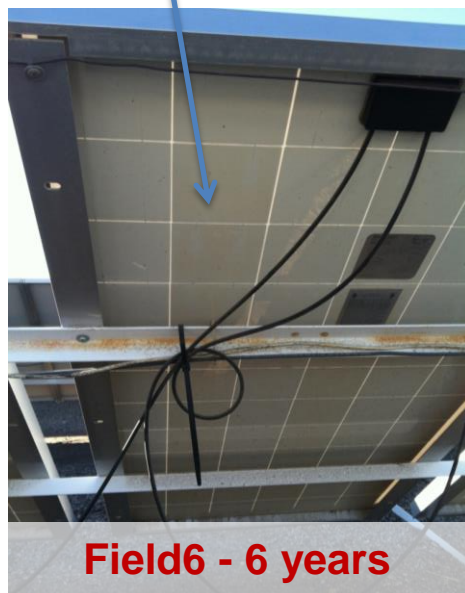
**Field6 - 6 years**

Failures from UV  
damage observed in the  
field early in expected  
module lifetime

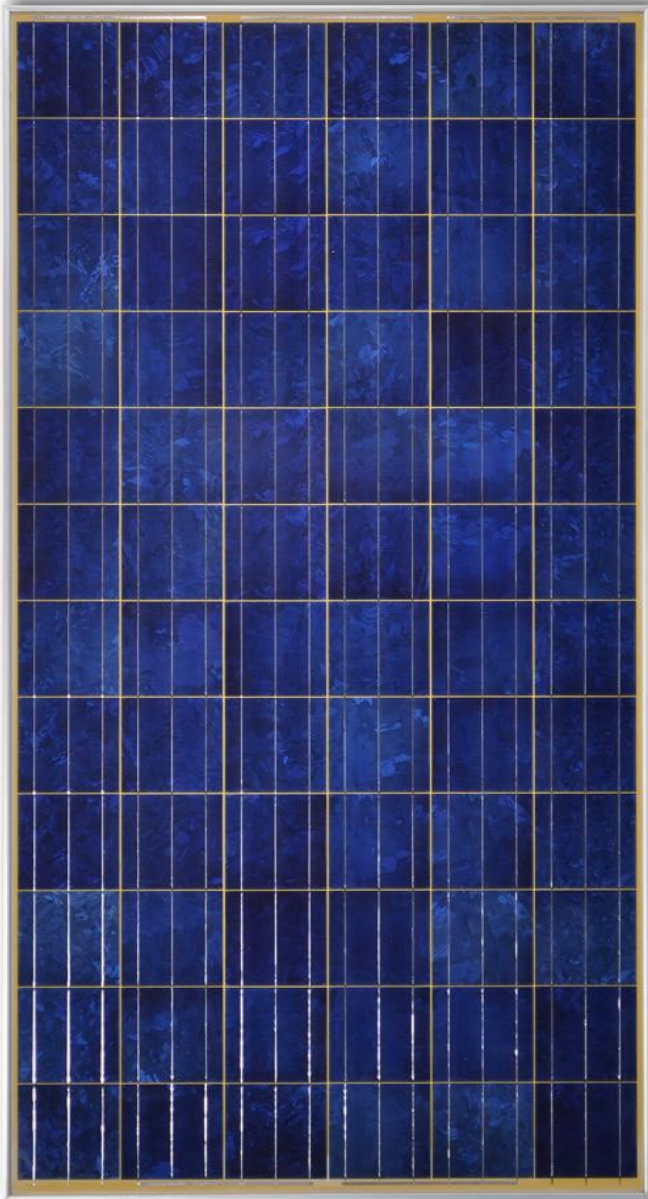
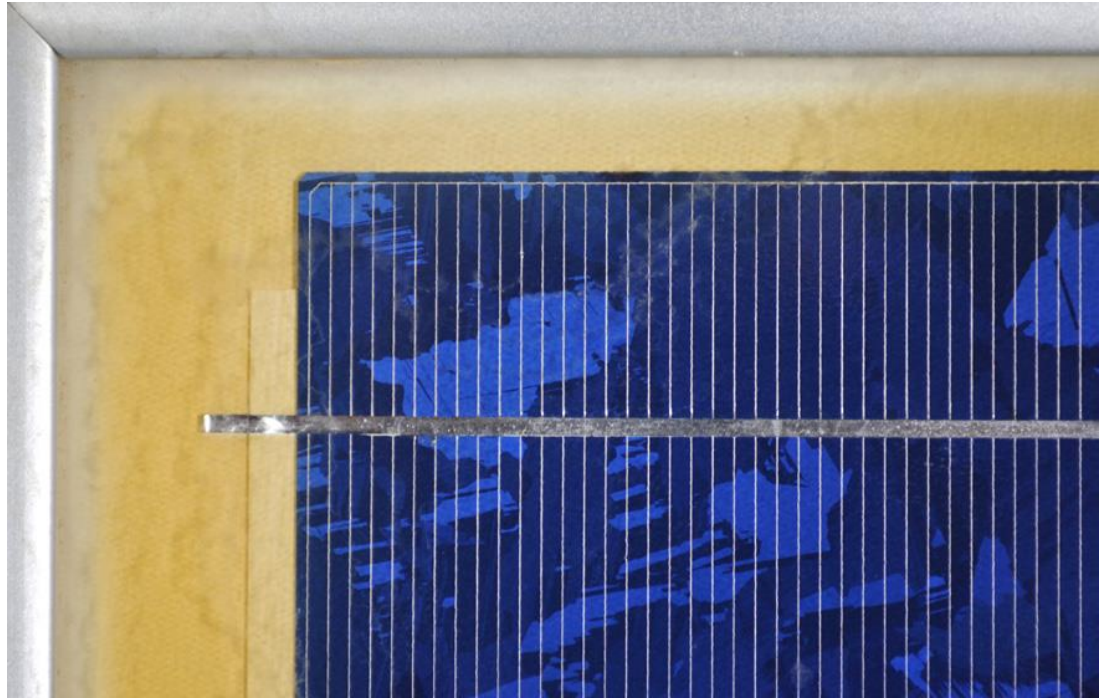
Front side yellowing observed in:

- 5 different countries (Belgium, Spain, USA, Israel and Germany)
- 5 different module manufacturers
- **Modules less than 5 years in the field**

Failures from UV damage observed in the field early in expected module lifetime

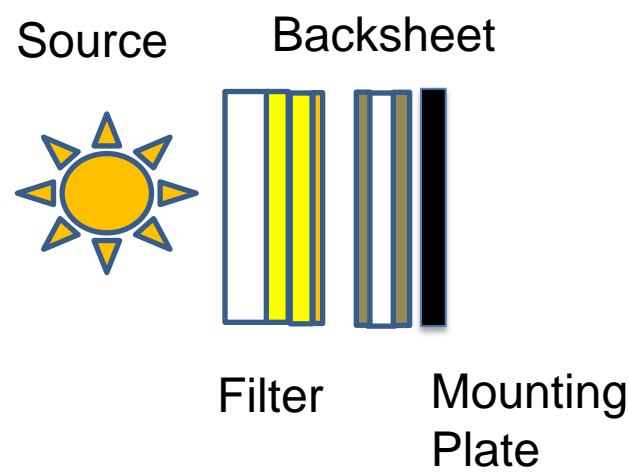
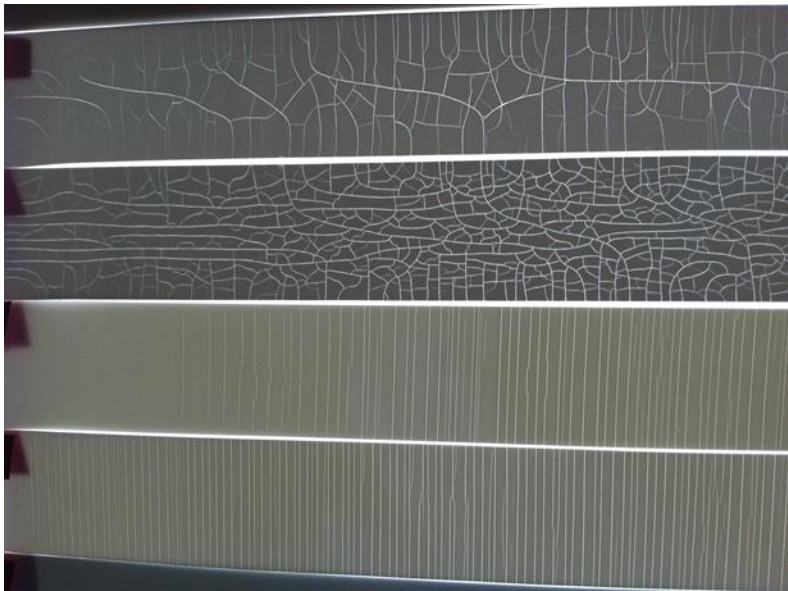
After 540kWh/m2 at 70C:  
Some single sided backsheet showing instability of the inner layer

High intensity metal halide “filtered” exposures are showing changes to the inner layer of some backsheets
